**DEPARTMENT OF TRANSPORTATION**

Contract #: 04-0120F4Cty: SF/ALA Rte: 80 PM: 13.2/13.9File #: 69.28**WELDING INSPECTION REPORT****Resident Engineer:**Siegenthaler, Peter**Address:** 333 Burma Road**City:** Oakland, CA 94607**Report No:** WIR-018155**Date Inspected:** 14-Nov-2010**Project Name:** SAS Superstructure**OSM Arrival Time:** 700**Prime Contractor:** American Bridge/Fluor Enterprises, a JV**OSM Departure Time:** 1900**Contractor:** Zhenhua Port Machinery Company, Ltd (ZPMC), Changxing Island **Location:** Shanghai, China**CWI Name:** Mr. Tian lei**CWI Present:** Yes No**Inspected CWI report:** Yes No N/A**Rod Oven in Use:** Yes No N/A**Electrode to specification:** Yes No N/A**Weld Procedures Followed:** Yes No N/A**Qualified Welders:** Yes No N/A**Verified Joint Fit-up:** Yes No N/A**Approved Drawings:** Yes No N/A**Approved WPS:** Yes No N/A**Delayed / Cancelled:** Yes No N/A**Bridge No:** 34-0006**Component:** Orthotropic Box Girder( OBG)**Summary of Items Observed:**

## WELDING INSPECTION REPORT

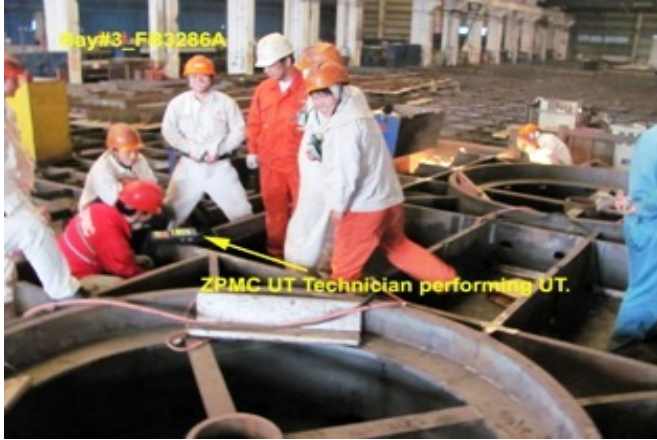
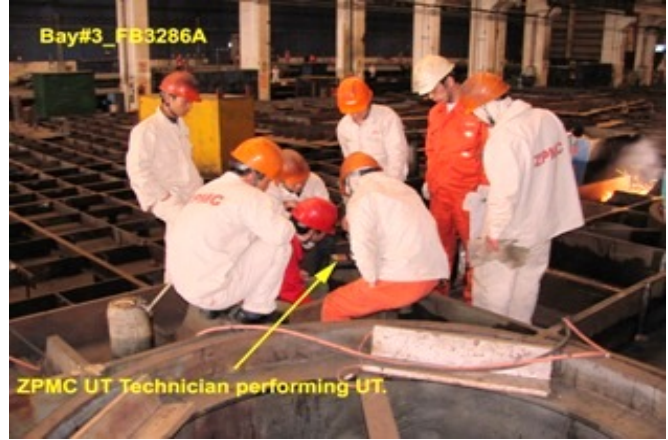
ZPMC UT Technician performing Ultrasonic Testing for the welds located on FB3286A. Refer the attached photos for reference.
